*Some engineering problems of the
Panama canal in their relation to ...*

Donald Francis MacDonald

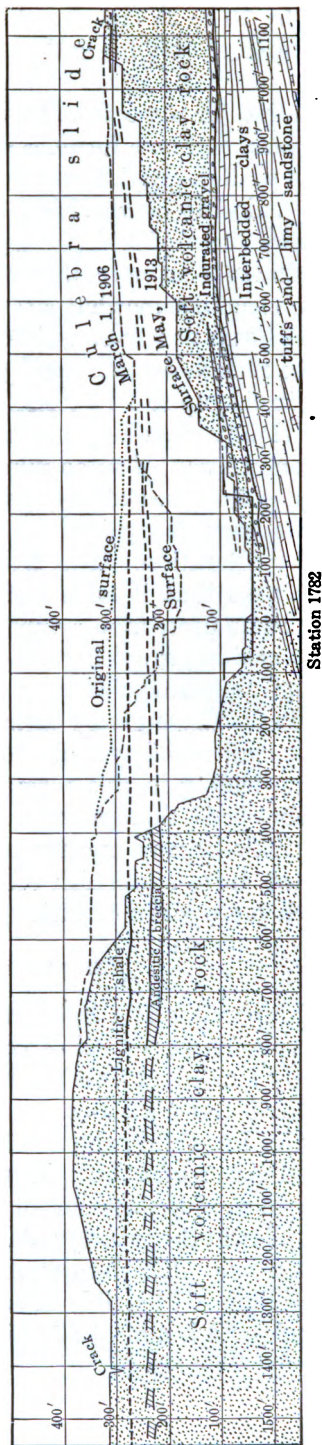
FIGURE 4.—Cross section of Culebra Cut at station 1782. As shown on left, a large crack developed at the surface, due to the fact that the rocks have deformed the excavation. This figure and figure 3 illustrate at what flat angles these rocks will slide.

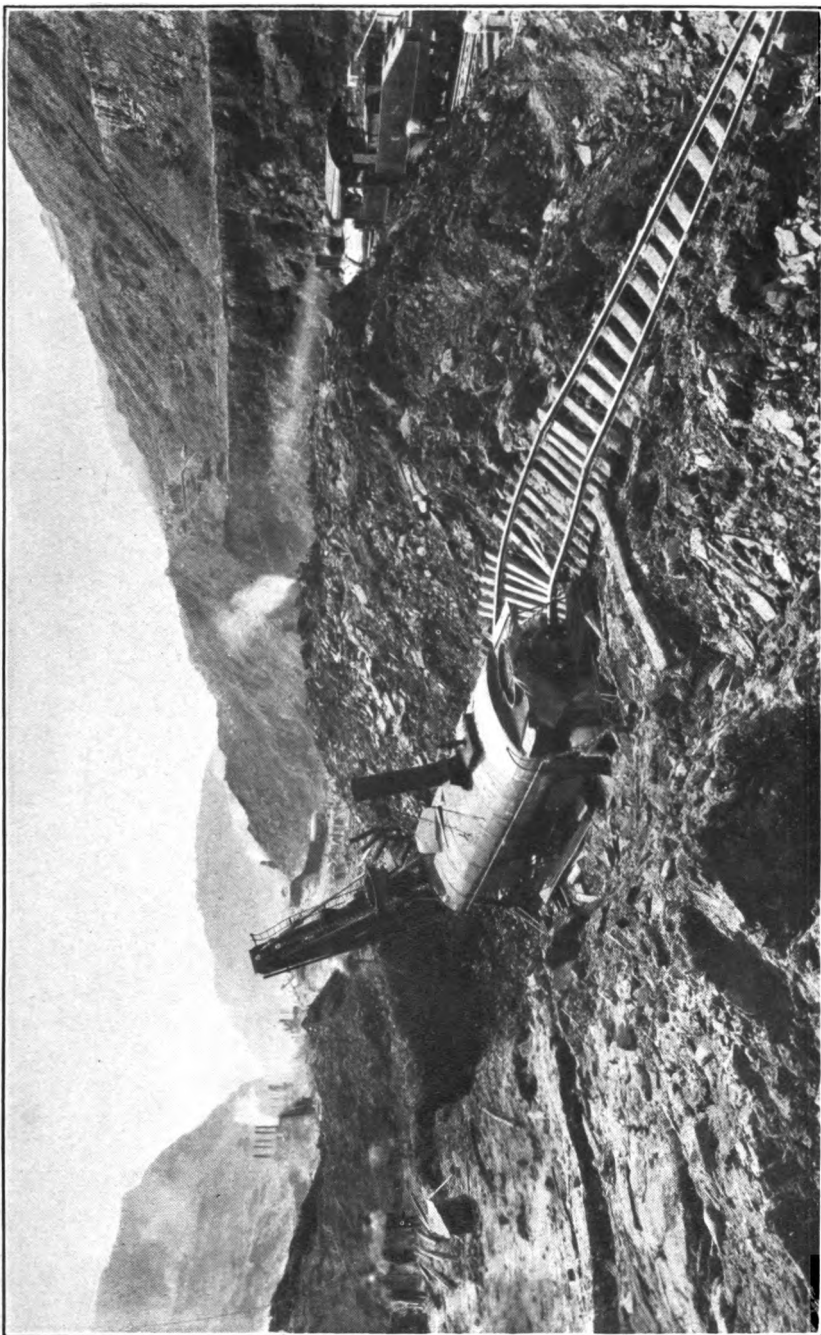
BULGING OF ROCKS IN BOTTOM OF CULEBRA CUT, CULEBRA, IN FRONT OF LARGE BREAK OR DEFORMATION SLIDE IN EAST BANK BETWEEN STATIONS 1746 TO 1758.

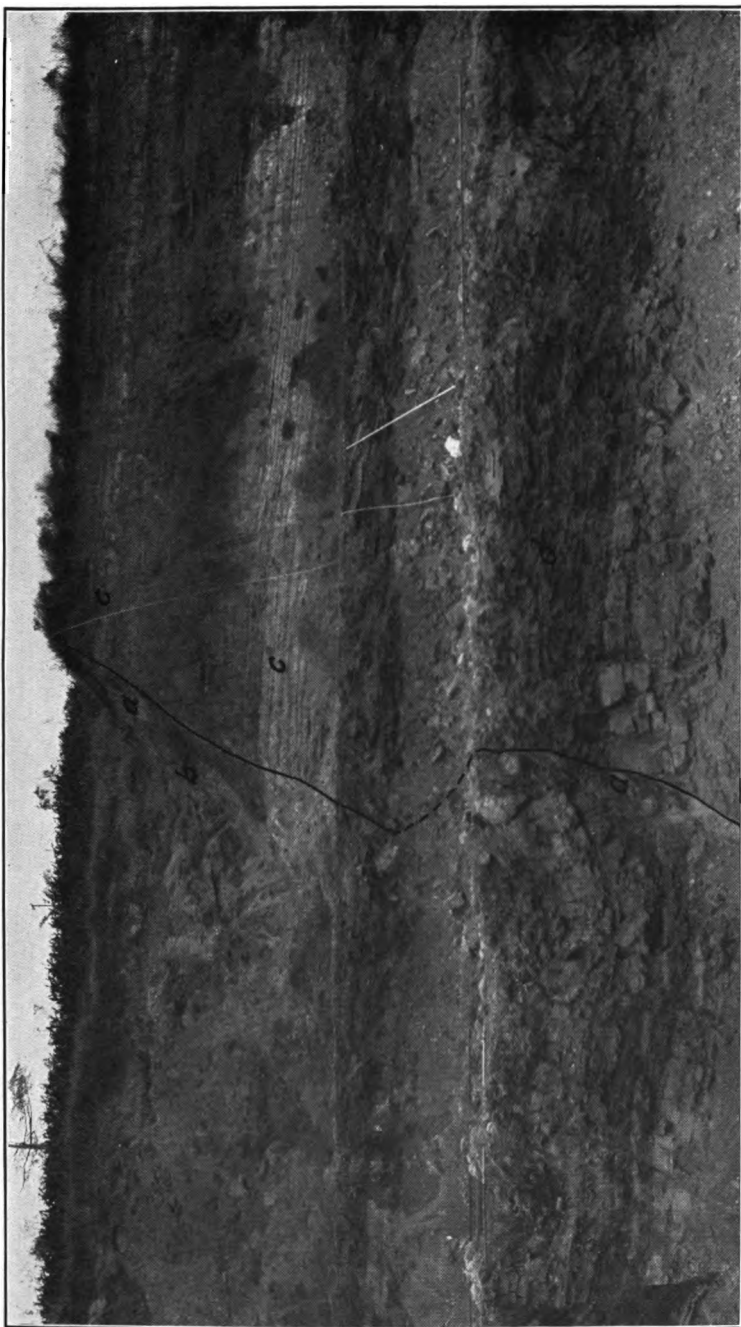
FAULT ZONE NEAR CULEBRA.

a, Fault plane cutting across canal. *b*, Zone of weakened sheared rocks. *c*, Limy sandstone beds which are stronger than the dark carbonaceous clay beds under them (see Plate XV, 1b). *d*, Dark carbonaceous clays and bedded tuff (Plate XV, 1b). Note how rocks on left of (*b*)—the overhang of the fault plane—have slid into the Cut.

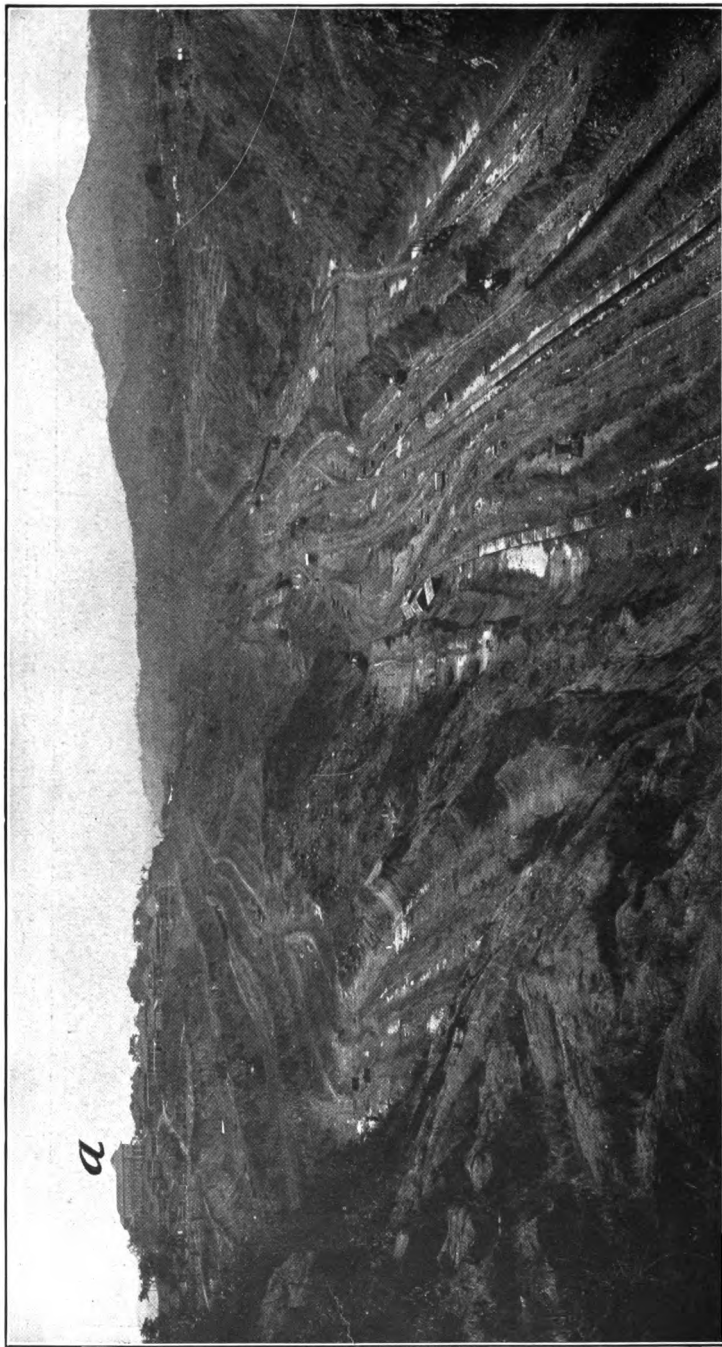
TERRACING ON BOTH SIDES OF CULEBRA CUT, NEAR CULEBRA, TO RELIEVE STRAINED CONDITION OF THE SLOPES. VIEW TAKEN FROM CONTRACTORS HILL, LOOKING NORTH.

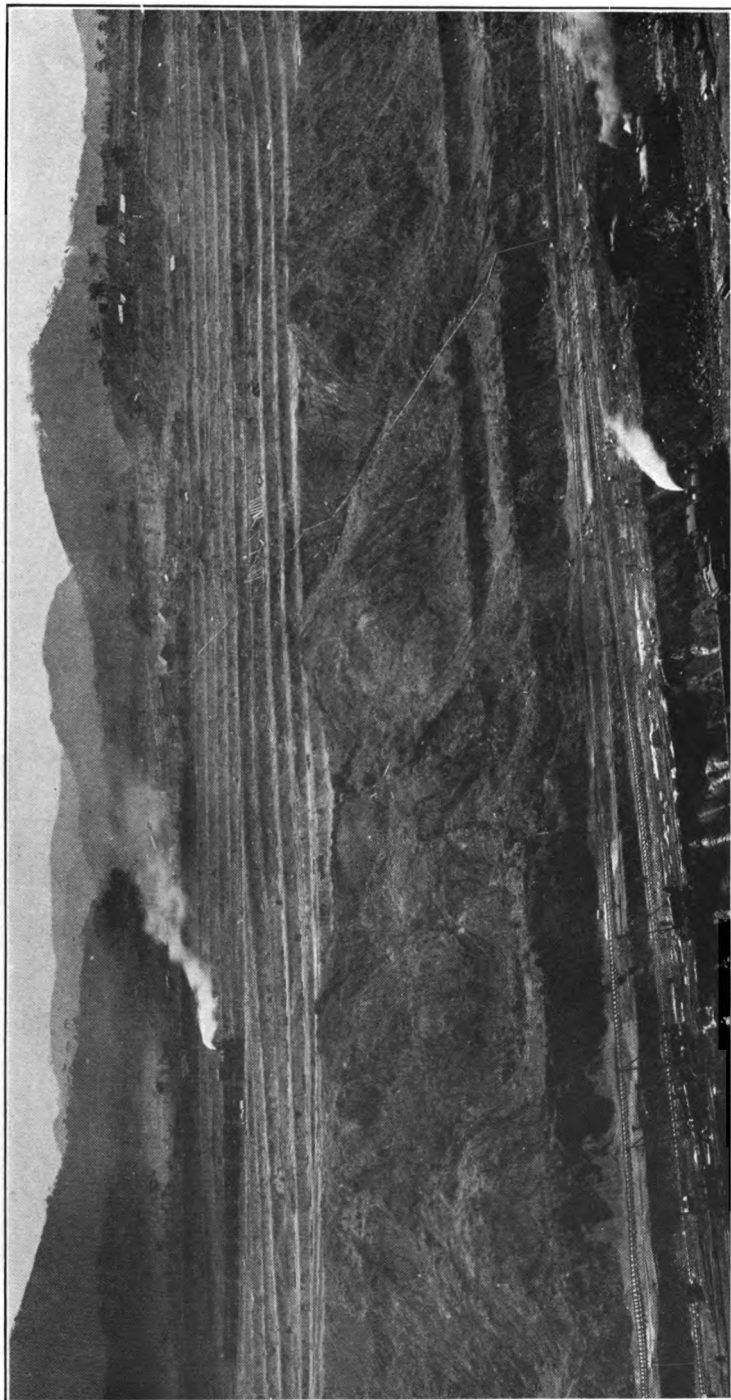
TERRACING TO RELIEVE STRAINED CONDITIONS OF SLOPES, EAST SIDE OF CULEBRA CUT, STATIONS 1735 TO 1765.

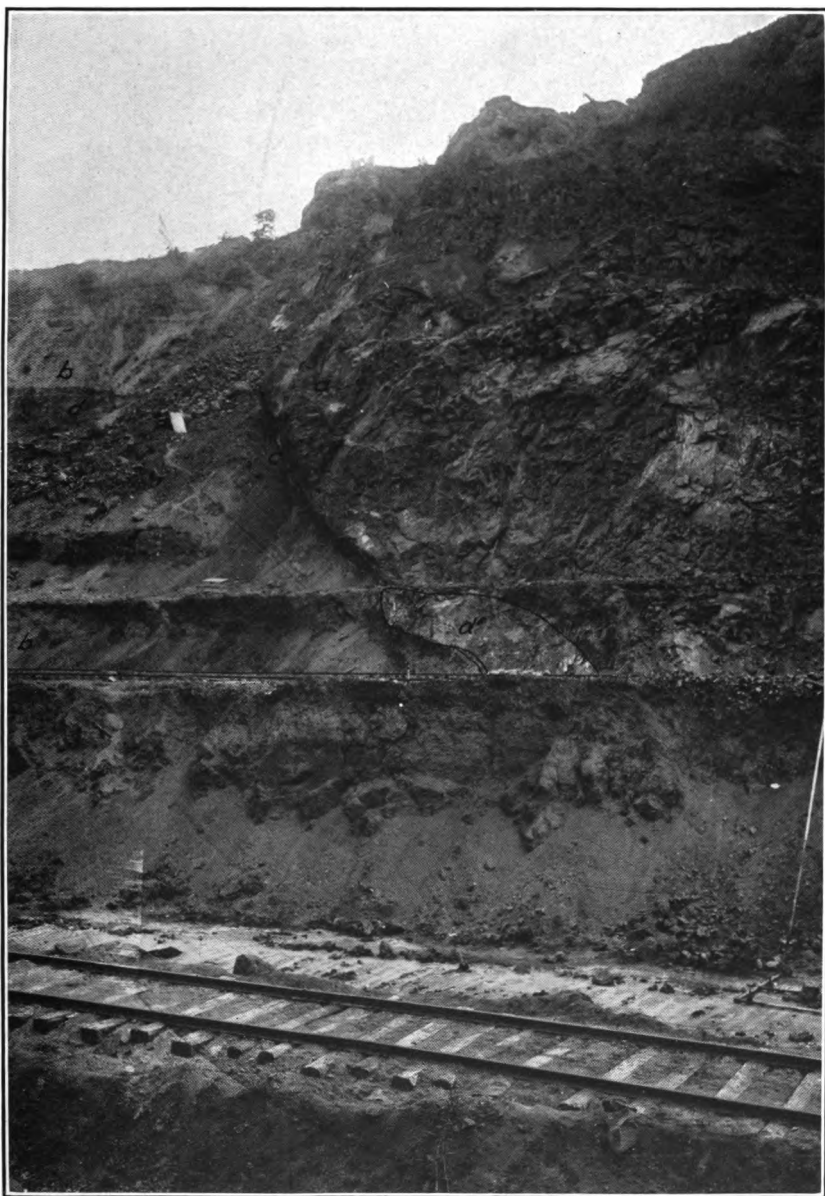
FAULT PLANE AT GOLD HILL.

a, Northerly edge of Gold Hill mass, part of the basalt dike which forms the northern and western periphery of this hill; *b*, Cucuracha formation; *c*, fault zone, which extends around hill mass. *d*, old lava flow; *d'*, mass of old lava pulled down from *d* (over 100 feet) by frictional drag of hill mass, as it was faulted downward in late geologic times.

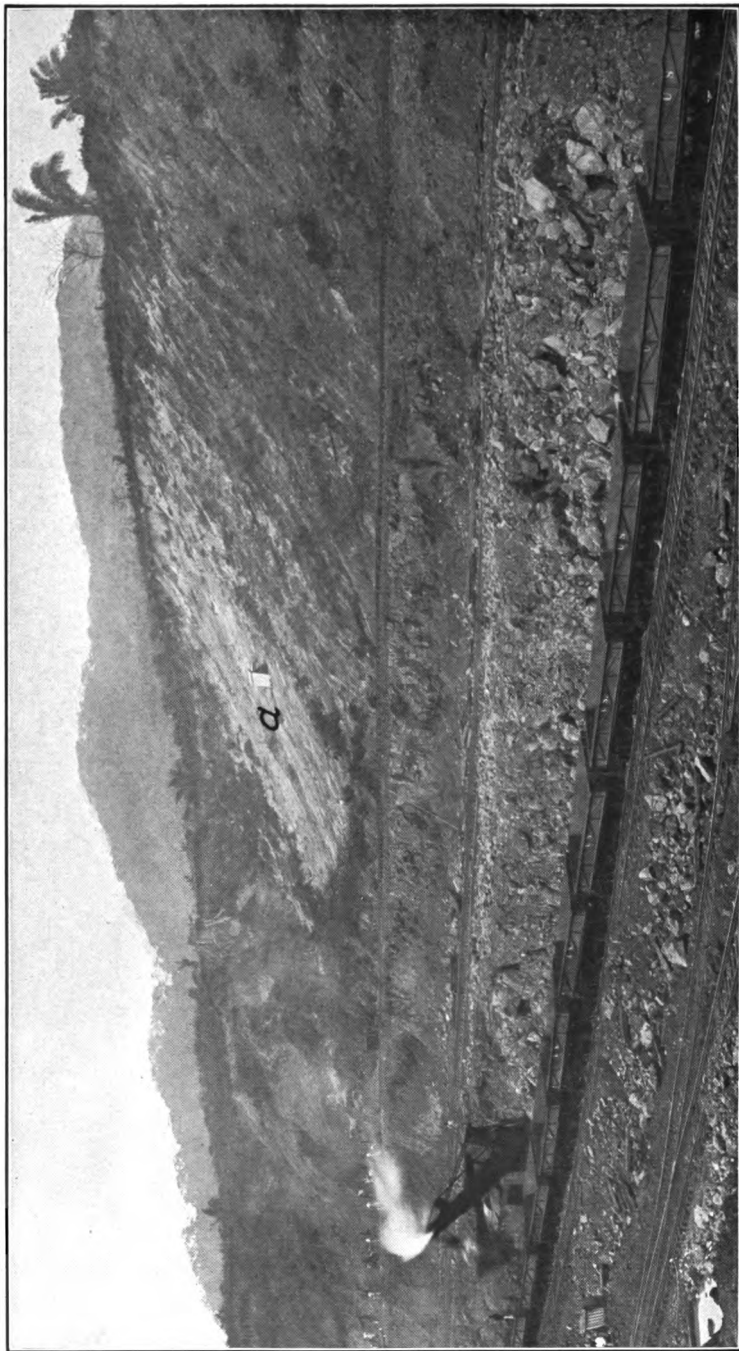
SLIDE NEARLY OPPOSITE LAS CASCADAS, ACTIVE IN 1908 AND 1909.

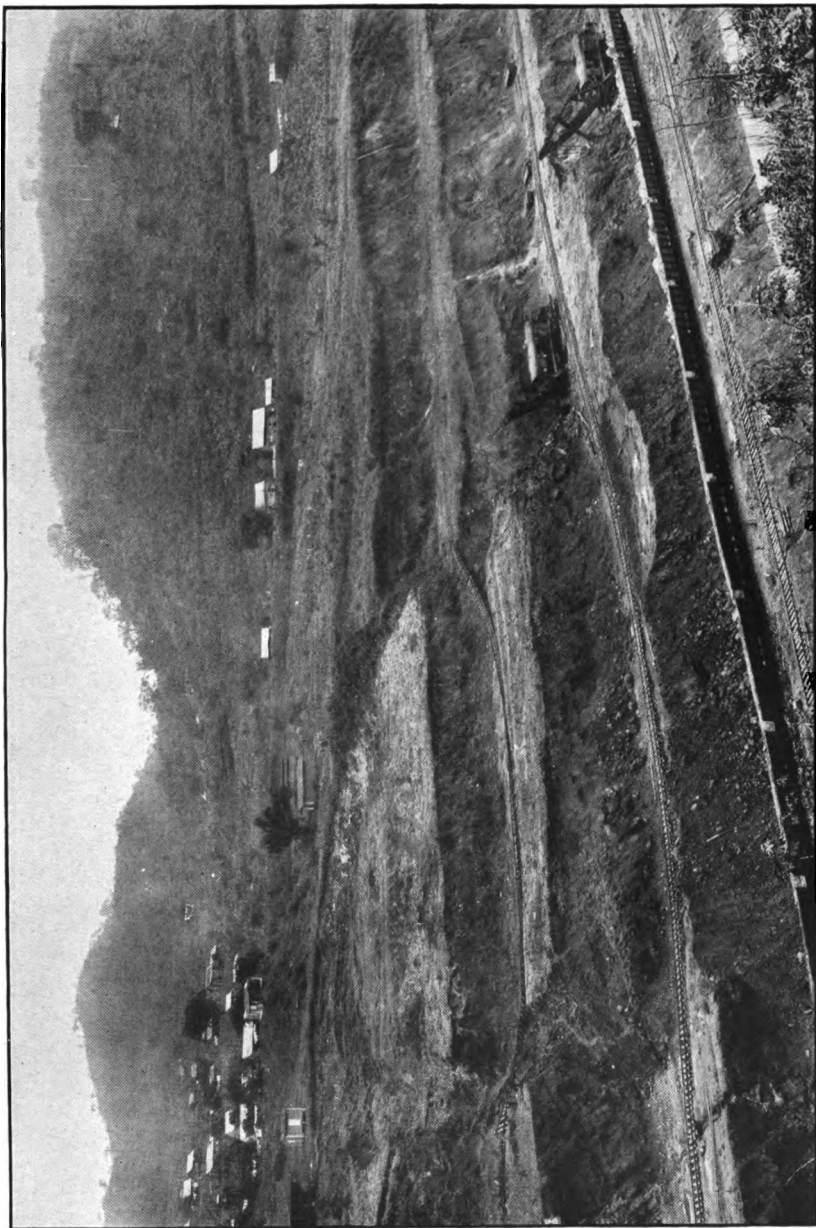
SLIDE NEAR CUCURACHA VILLAGE, EAST SIDE OF CULEBRA CUT.

Slide included 231,000 cubic yards.

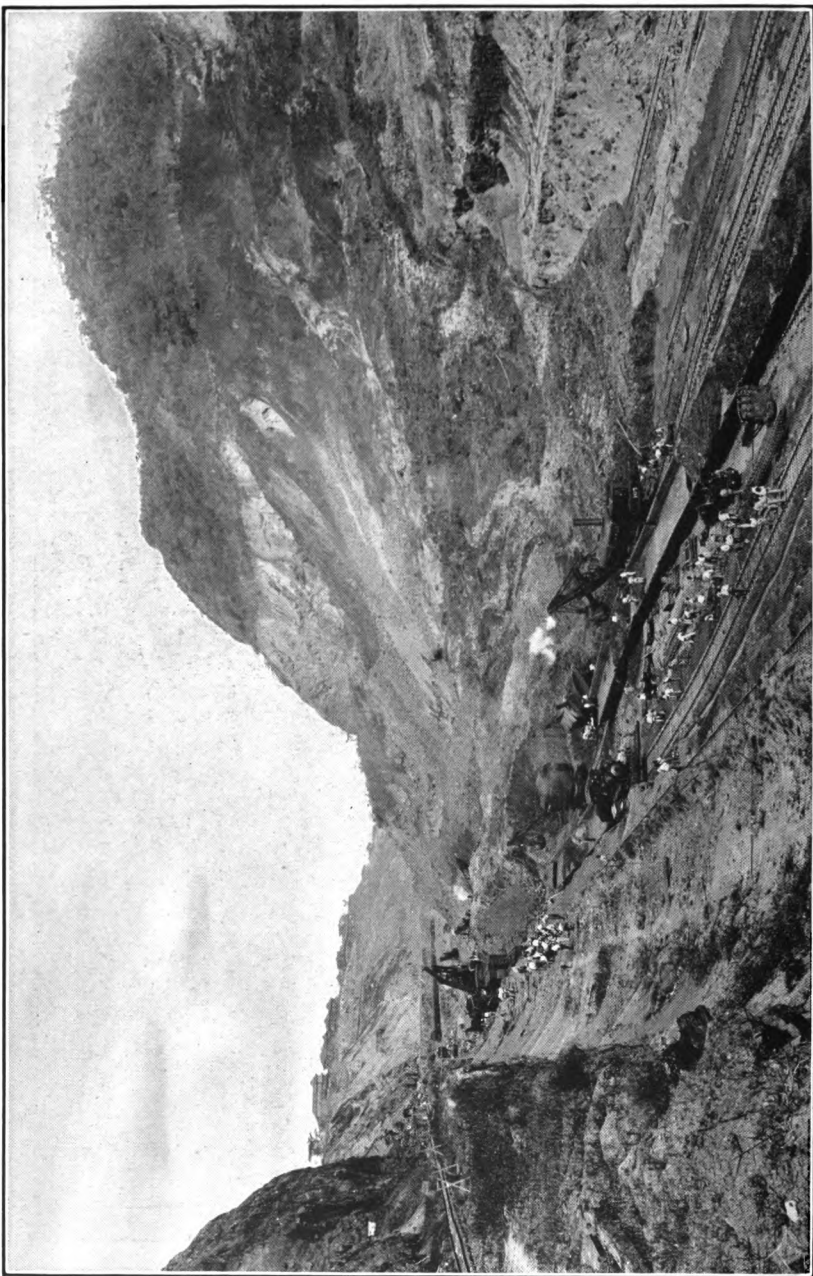
CUCURACHA SLIDE, LOOKING NORTH FROM WEST BANK, SOUTH OF CONTRACTORS HILL, FEBRUARY 7, 1913. NOTE STEAM SHOVEL TILTED OVER BY SLIDE.

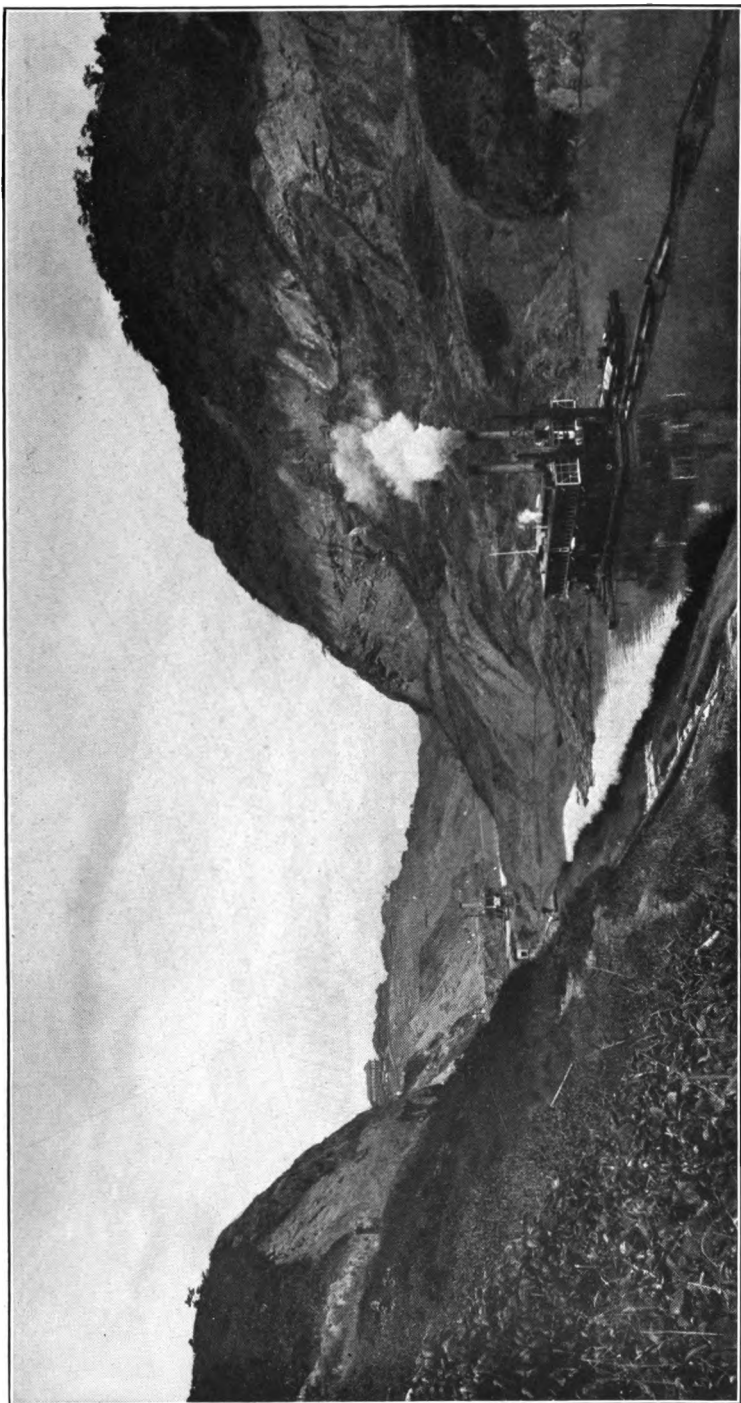
DREDGES WORKING ON CUCURACHA SLIDE AFTER THE WATERS HAD BEEN TURNED INTO CULEBRA CUT.

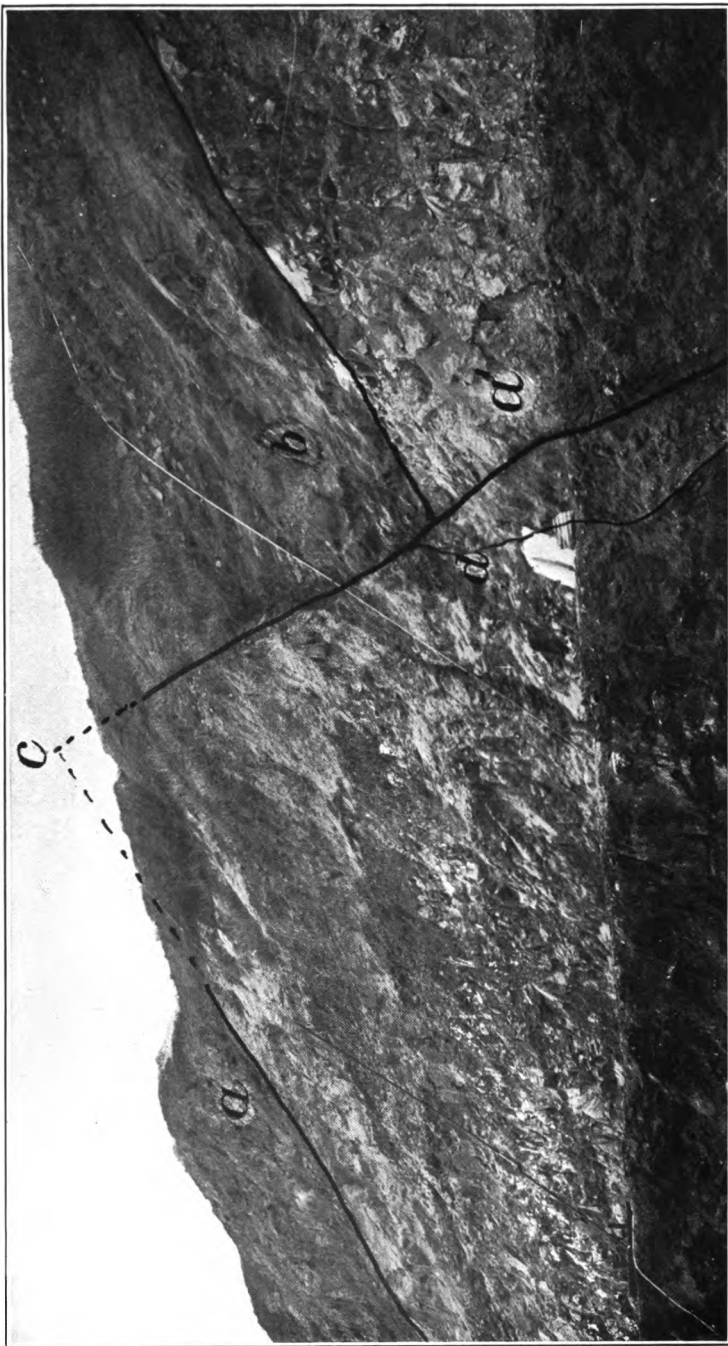
FAULT OR BREAK IN ROCKS ON WEST SIDE OF CULEBRA CUT NEAR STATION 1652.

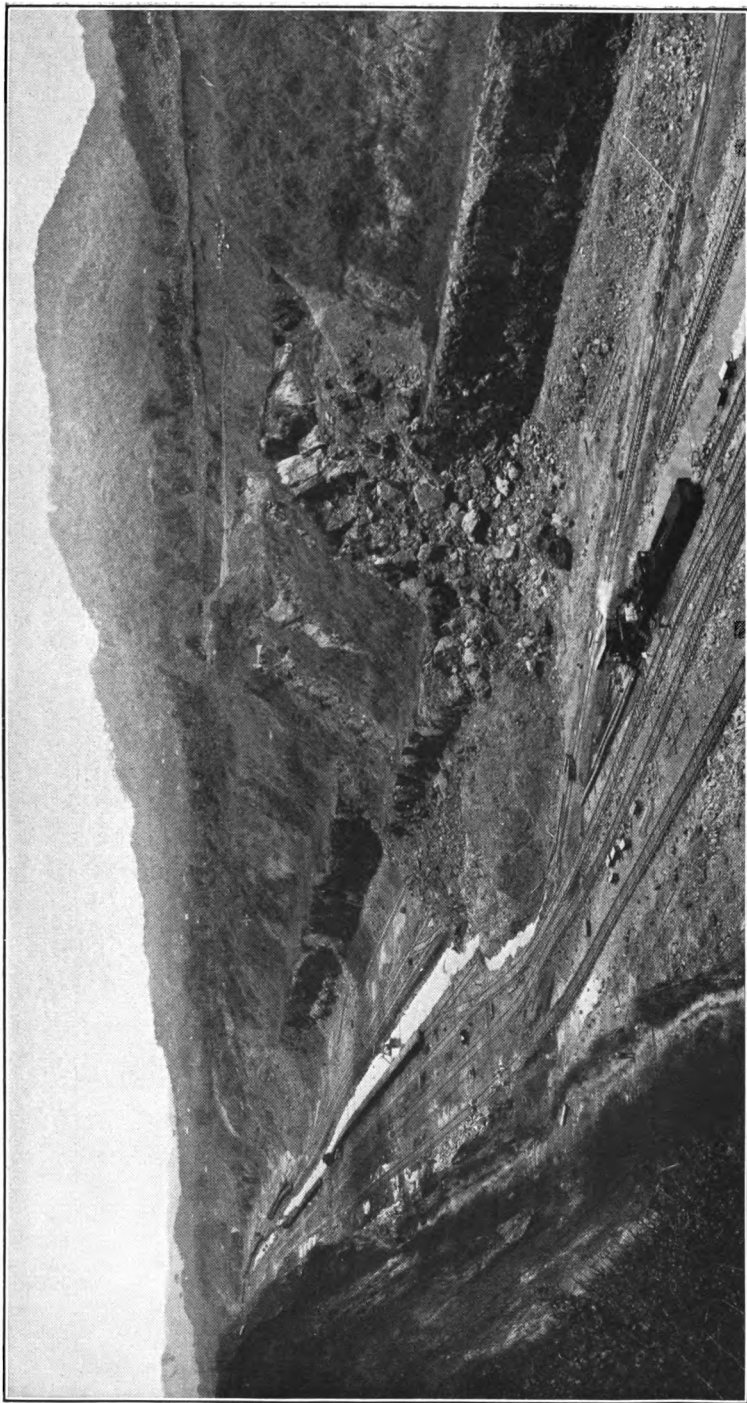
SLIDE ON EAST SIDE OF CULEBRA CUT, NEAR STATION 1652. INCLUDED NEARLY 300,000 CUBIC YARDS OF ROCK. CAUSED LARGELY BY WEAKENING EFFECTS OF FAULT SHOWN IN PLATE XXV.

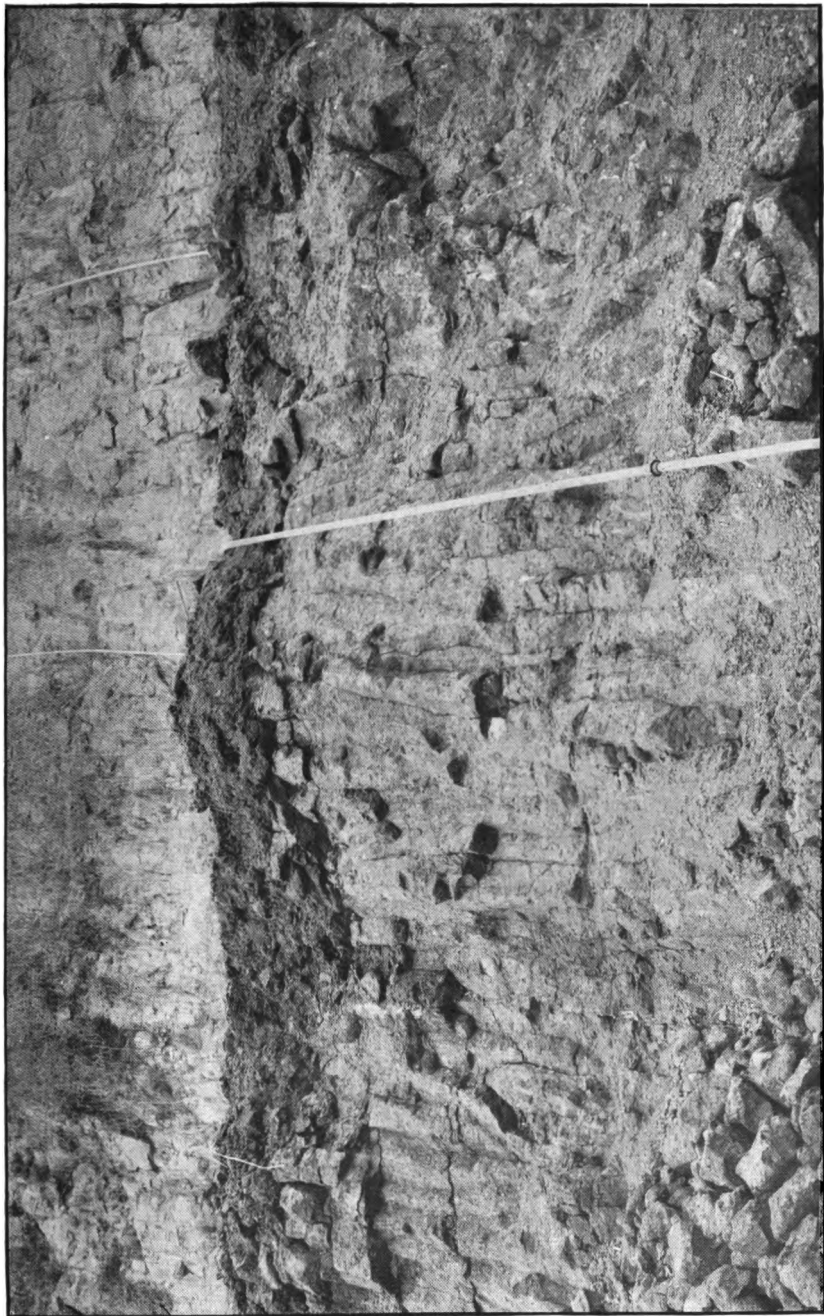
COLUMNAR STRUCTURE IN HARDENED FLOWS OF MUD-LAVA. THIS JOINTING AFFORDED PASSAGES FOR SEEPAGE WATER FROM THE OBISPO DIVERSION AND FROM GROUND WATER WHICH SOFTENED THE BASAL MASS, ALREADY UNDER HIGH PRESSURE, AND THUS TENDED TO PROMOTE THE LARGE SLIDE AT STATION 1652 SHOWN IN PLATE XXVI.

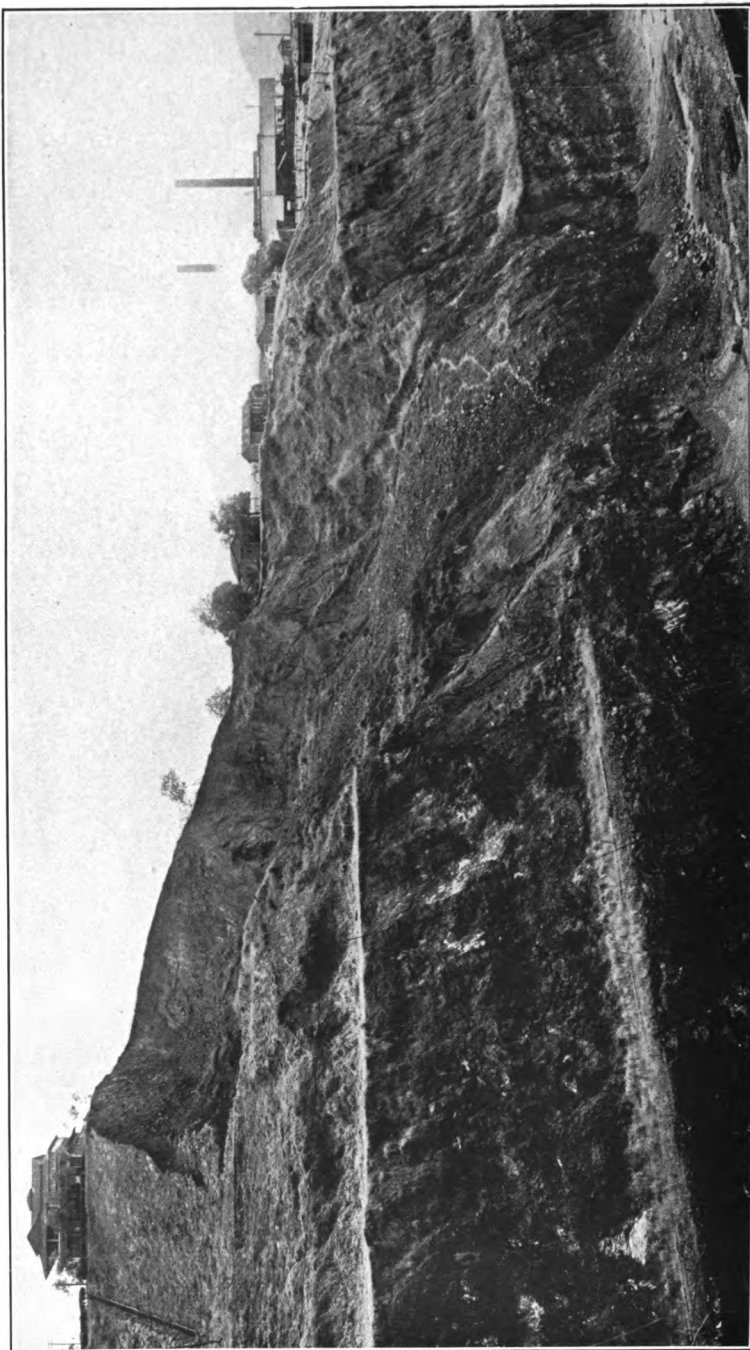
SLIDE NEAR DIVISION OFFICE, THE BUILDING ON THE LEFT, EMPIRE.
